The Ruins of the Gas Chambers: A Forensic Investigation of Crematoriums at Auschwitz 1 and Auschwitz-Birkenau

Daniel Keren, Jamie McCarthy, and Harry W. Mazal

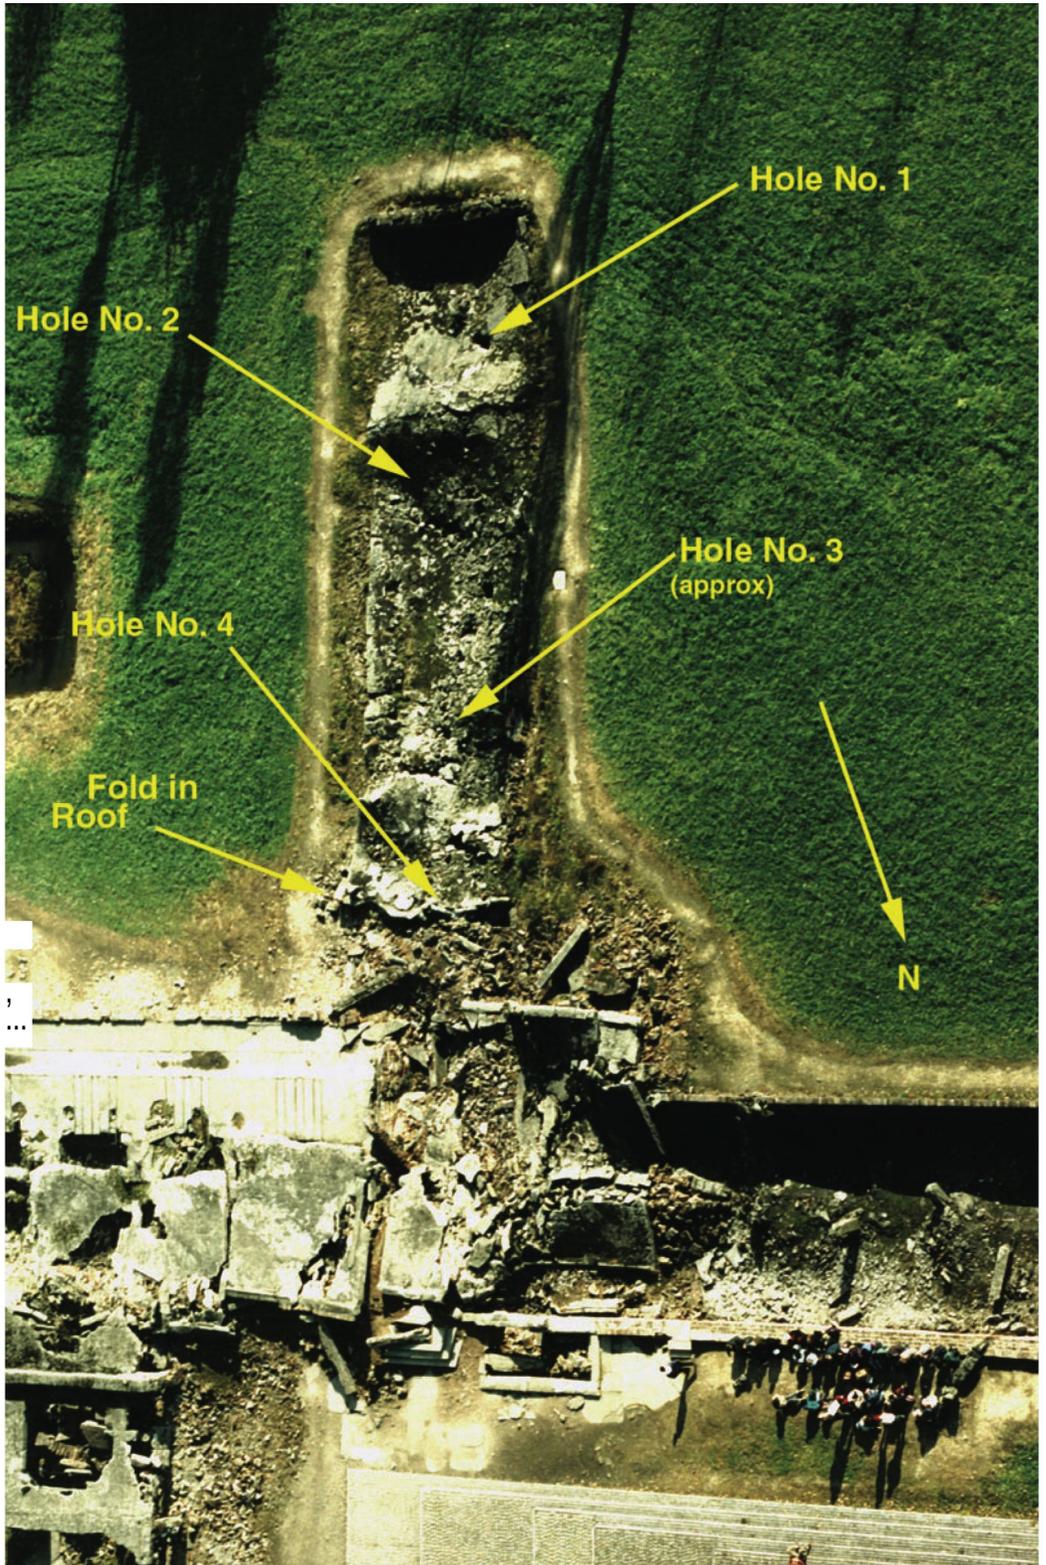
The search for the holes is quite a complex task, as both Crematoriums II and III were dismantled in late 1944 and later dynamited by SS sappers in January 1945 before they fled Auschwitz. The structures suffered considerable further deterioration in the following decades (see Figures 1a, b, and c).

Figure 1a. Aerial photograph of the gas chamber in Crematorium II (courtesy of Wojciech Gorgolewski).

Figure 1b. Ruins of gas chamber in Crematorium II today.

Figure 1c. Ruins of Crematorium II today.
